# STRUCTURAL APPRAISAL REPORT

Document Ref: HH-2235-C01 (Revision 0)

**Maulden Pavilion**

**Project Address:** The Maulden Recreation Ground Pavilion

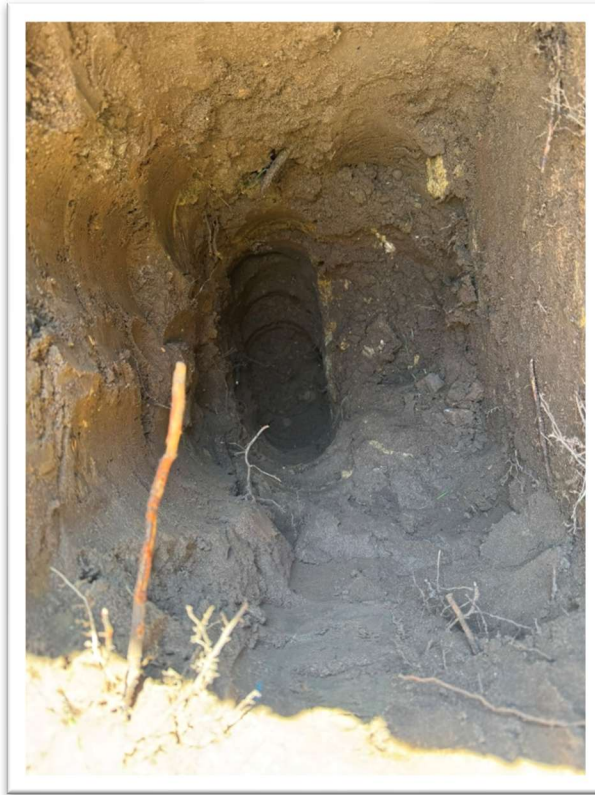
A trial pit was undertaken at the time of inspection. The foundations were found at approximately 1.2 m below ground level and comprise mass concrete strip footings approximately 600 mm wide and 300 mm thick.

The soil profile encountered was predominantly sand with minor clay content. On this basis, the ground is considered to have low volume change potential and is not considered susceptible to significant shrink–swell behaviour. The existing foundations are therefore considered adequate for typical loading associated with low-rise structures of this type.

Photo 1: Trial pit showing foundation depth and sandy soil strata

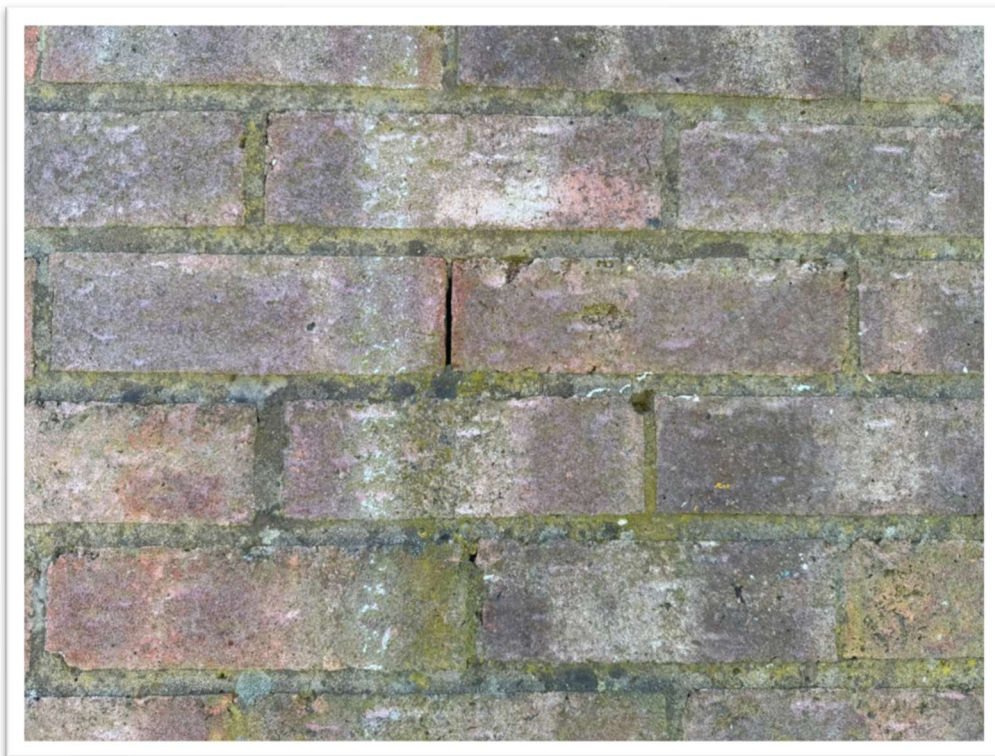
openings. These defects are superficial and consistent with age-related weathering rather than structural distress.

Photo 2: External brickwork with minor vertical cracking to mortar joint

Localised maintenance works should be undertaken, including repointing, replacement of damaged bricks, and sealing of minor cracks. A suitable rainwater drainage system should also be installed to prevent water discharge adjacent to the foundations.

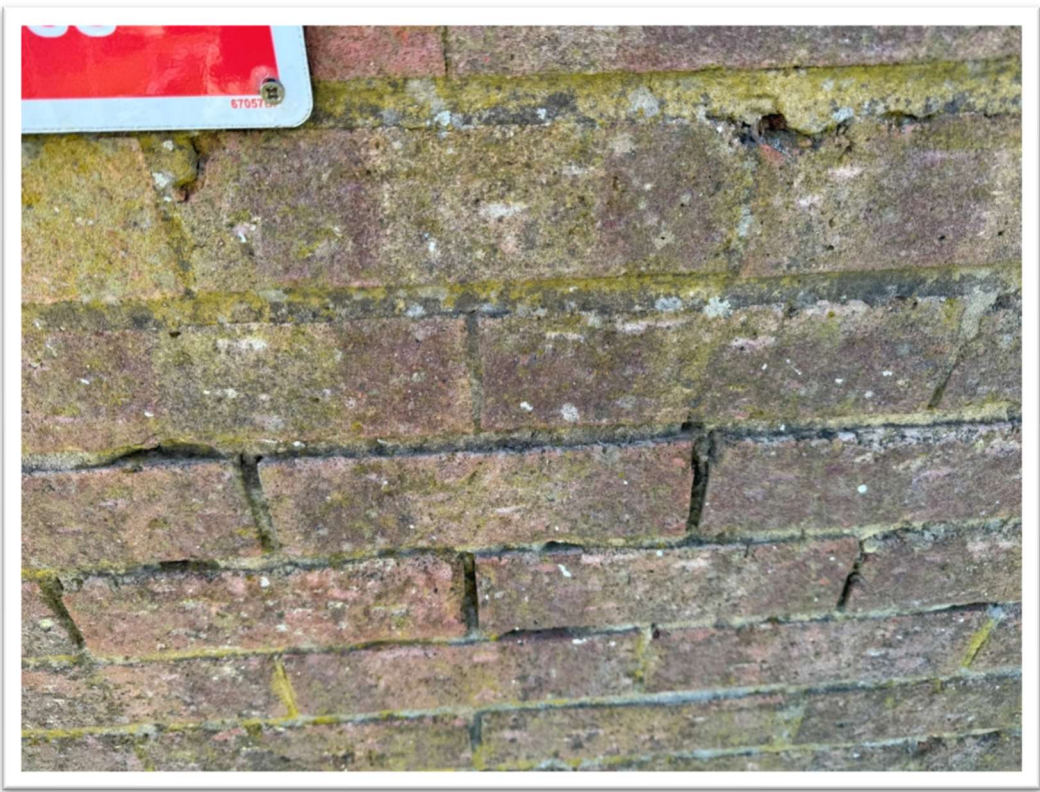
Photo 3: Localised brick spalling and weathering to external wall.

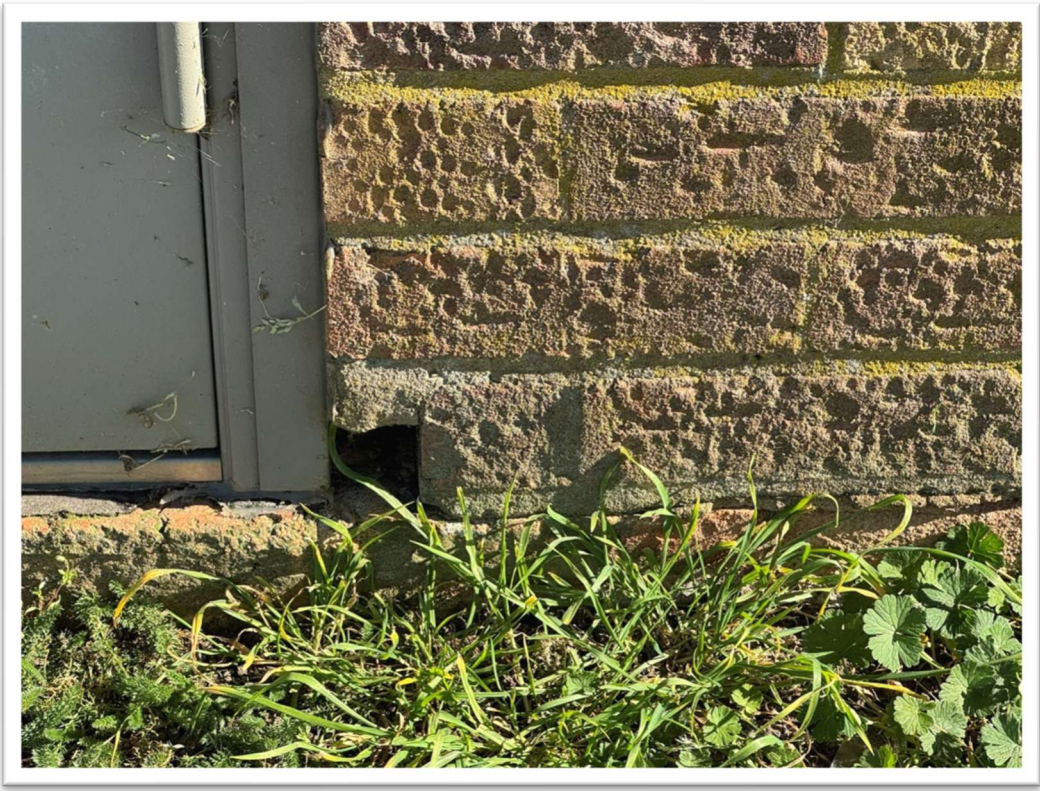
Photo 4: Localised missing brick at low level to external wall

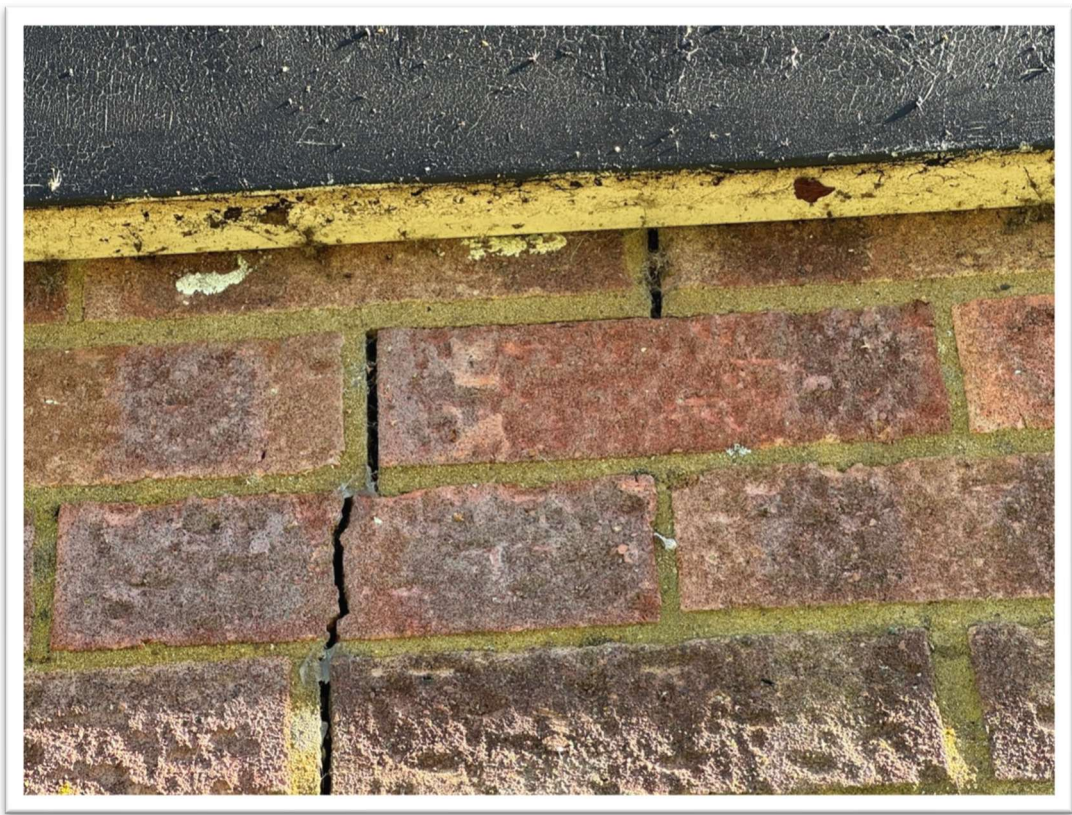
The structure is generally in good condition. The external walls are plumb with no evidence of significant movement or distortion. Localised defects were noted, including areas of mortar deterioration, minor brick spalling to isolated locations, and limited, fine cracking above

Photo 5: External wall above opening showing localised cracking

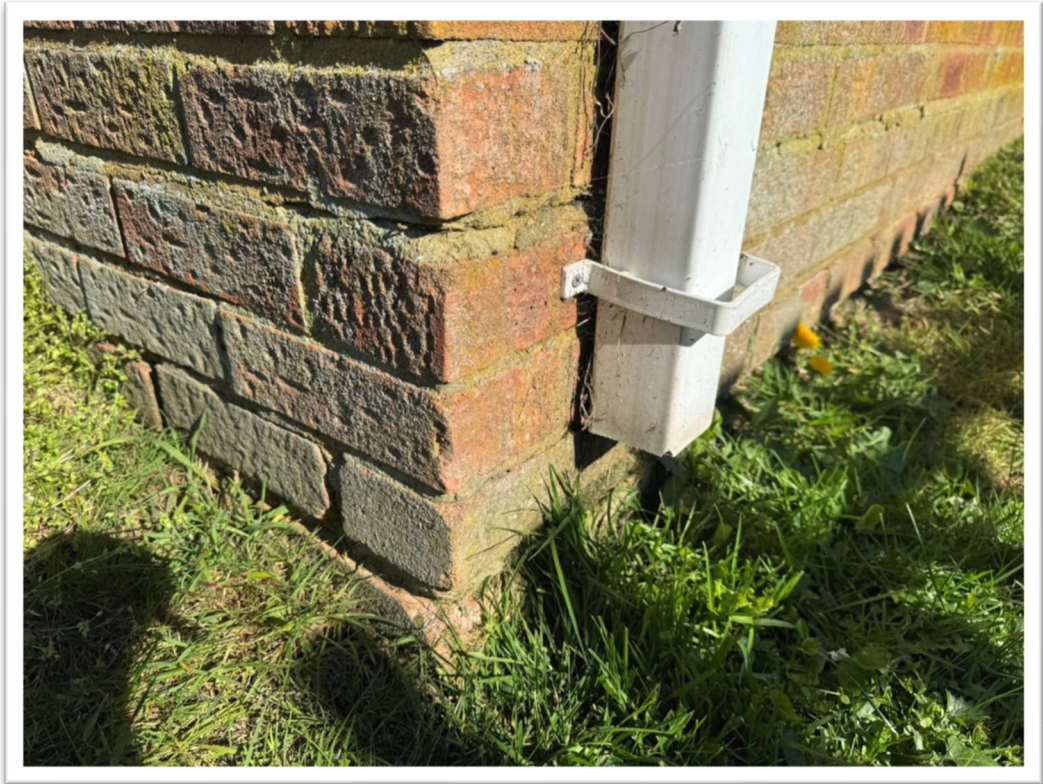
Rainwater disposal is currently inadequate, with no clear provision for directing water away from the base of the building. This presents a risk of localised softening of the ground if left unaddressed.

The lack of effective rainwater management should be addressed, as prolonged saturation of the ground adjacent to the foundations could lead to deterioration over time.

Photo 6: Downpipe discharge adjacent to wall with potential for water saturation

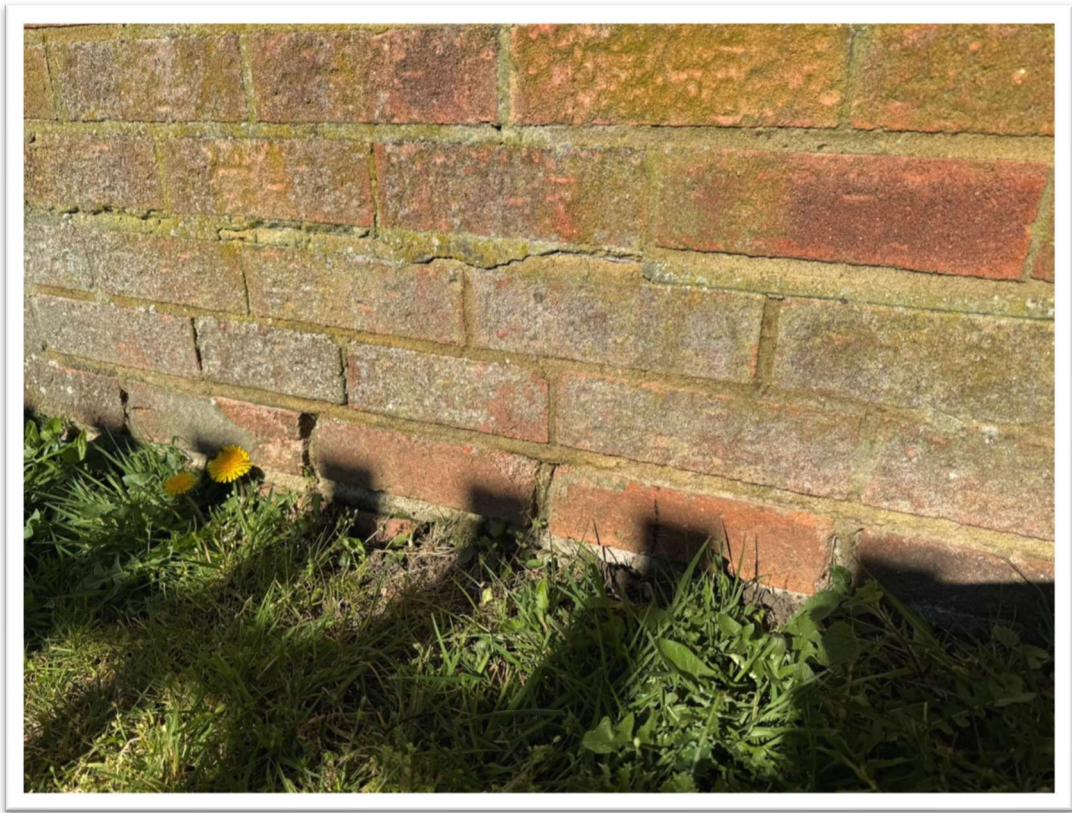
Photo 7: Horizontal cracking and mortar deterioration to external brickwork

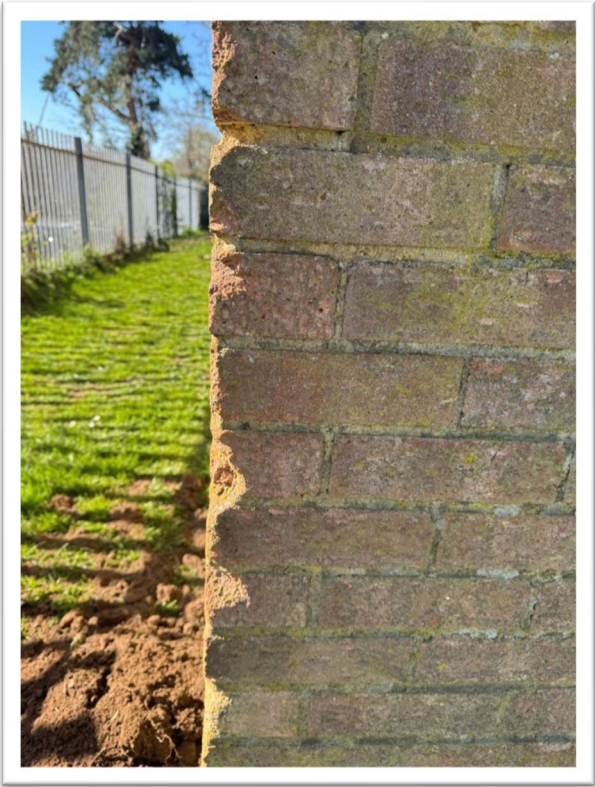
Photo 8: Localised brick spalling and weathering to external corner detail

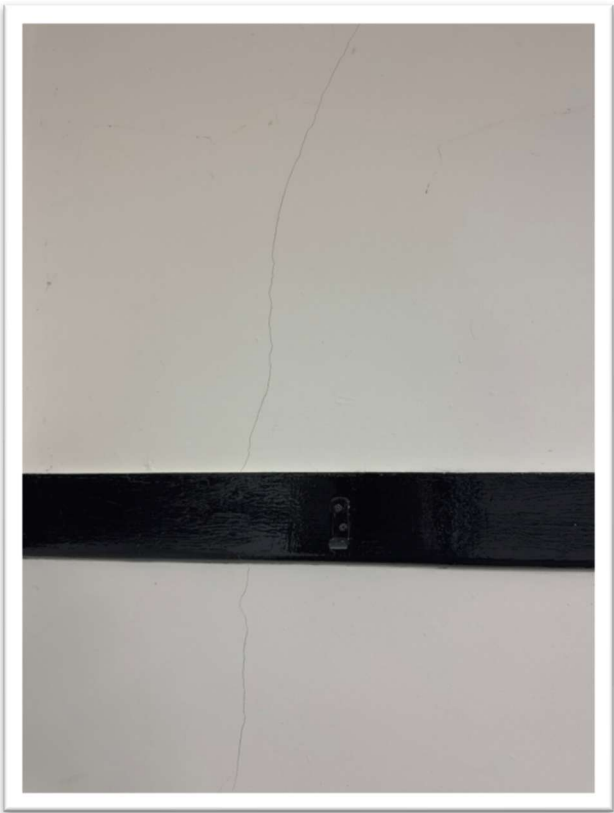
Internally, minor cracking to plasterboard finishes was observed. This does not correlate with external cracking and is considered non-structural.

Photo 9: Internal wall with vertical hairline cracking to plaster finish

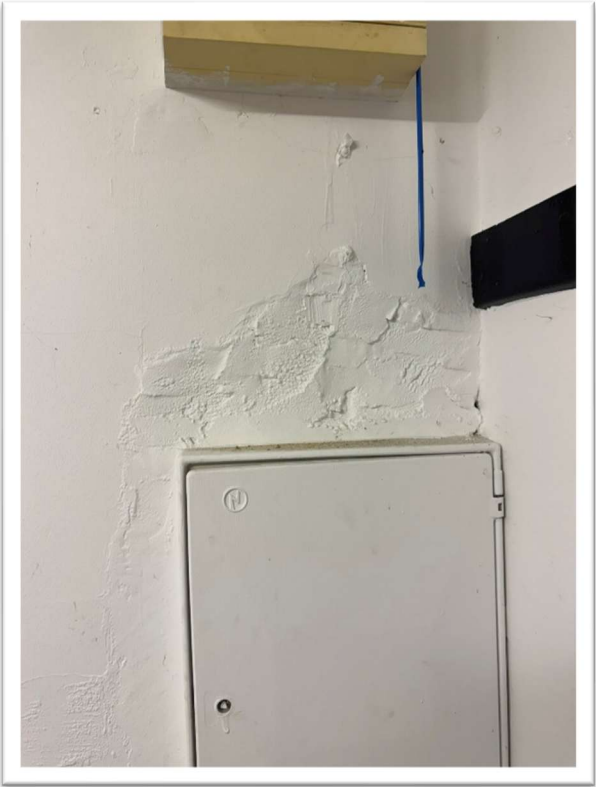
Photo 10: Internal wall with previous repair and uneven plaster finish

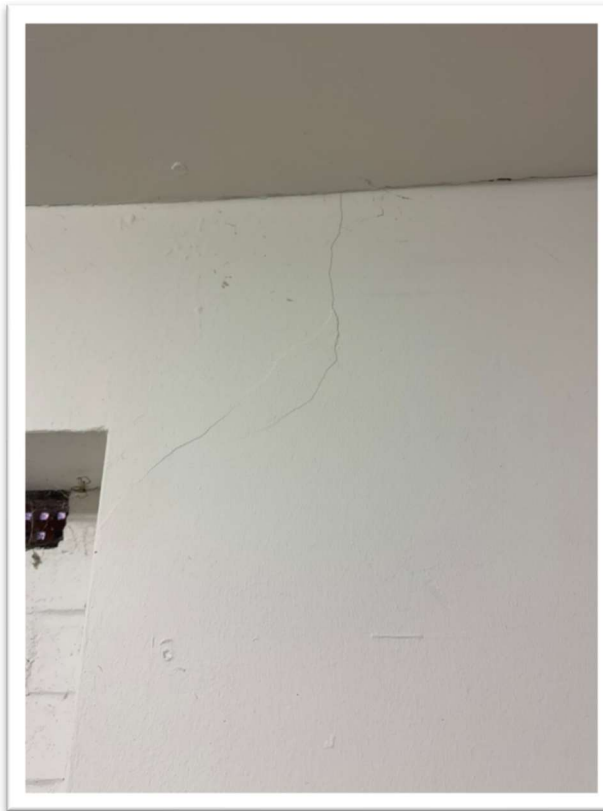
Photo 11: Internal cracking at wall/ceiling junction

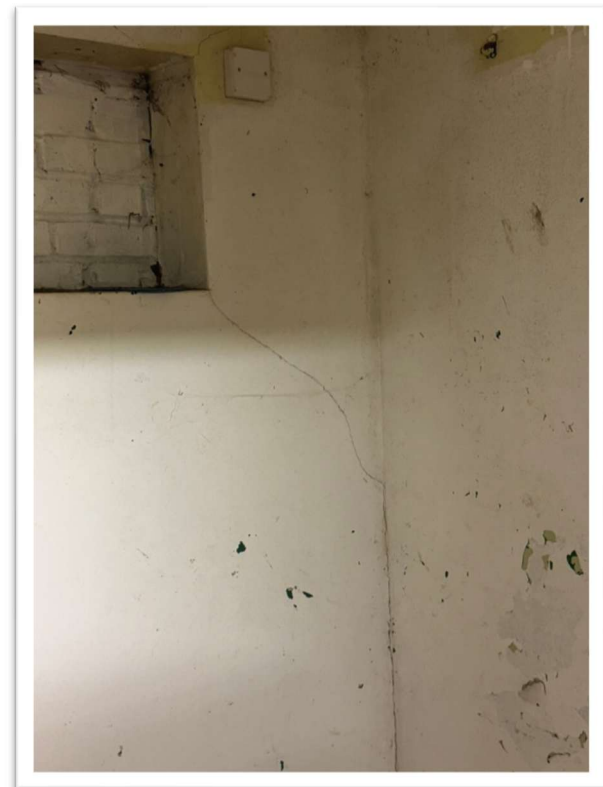
Photo 12: Internal corner cracking and localised surface deterioration
