# Safety Inspection Report

## Maulden Recreation Ground

Maulden Parish Council

08 June 2026

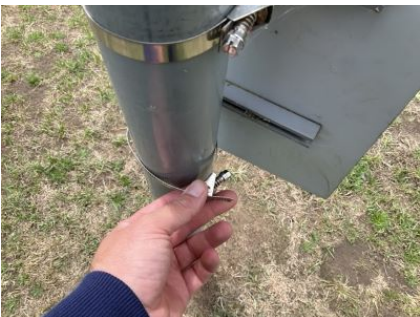
| Description |
|---|
| Minor repairs are needed. |
| Cut back excess metal tails on sign. |

| Description |
|---|
| Read the notes for further action. |

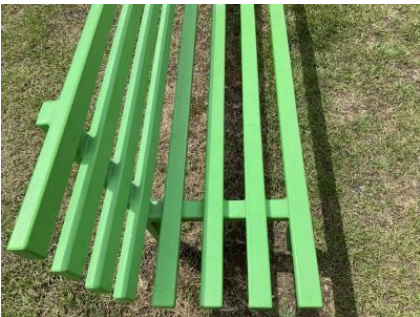
The gaps between the slats exceed 30 mm and are known to cause entrapments.

No reasonably practicable action is identified.

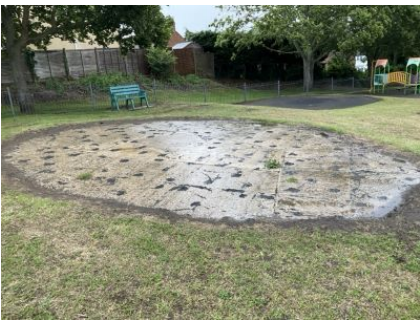
| Surface needs repair. |
| Old slide towers surface. Repair. |

| Repair. |

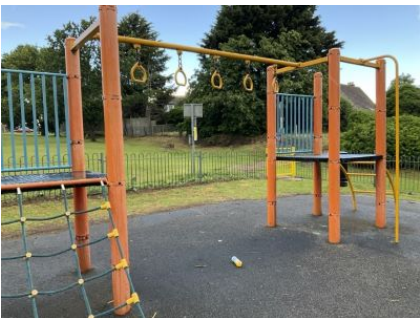
Overhead ladders and rings provide significant play value and benefits to children, and with it the risk of falling. Ensuring the surface remains in good condition will help to keep the correct balance between benefits and risk.

If possible, on angled or S-shaped bars, consideration should be given to level bars with firm grips and even spacings. The protective surface under all bars and rings must be kept in good condition.

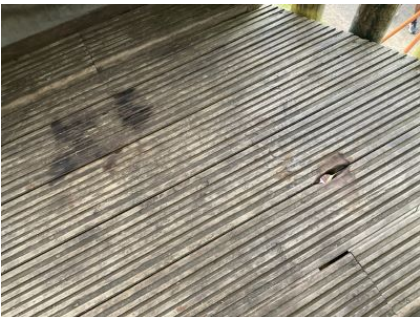
Small arson to top decking, monitor and replace when necessary.

Monitor for significant deterioration and repair/replace as necessary.

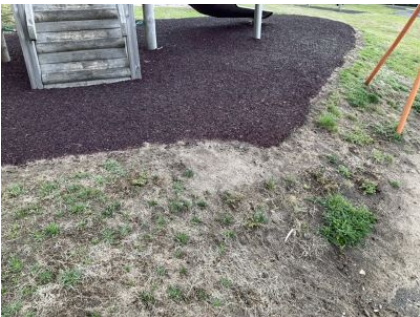
Worn ground areas.

Edges of surfacing have collapsed. Repair.

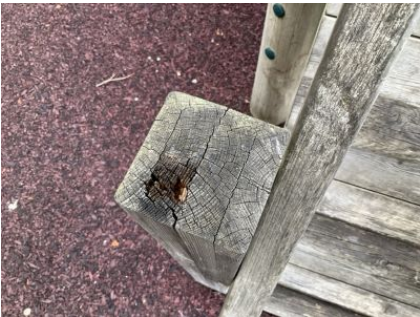
Minor rot to tops of posts. Monitor.

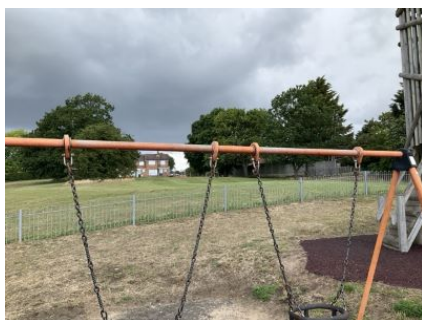
The anti-wrap shells are worn.

Anti-wrap shells are wearing.

Replace.

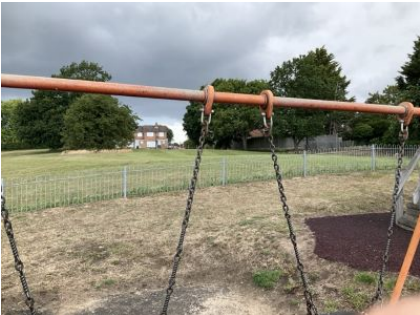
There is wear in the bushes.

Minor wear.

Remove shackle bolt and check bush and shackle pin wear, replacing as necessary.

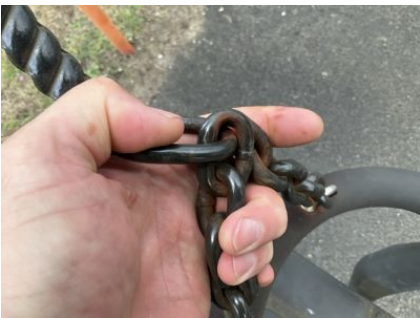
Some chain wear.

Monitor for further deterioration and replace before 40% wear.

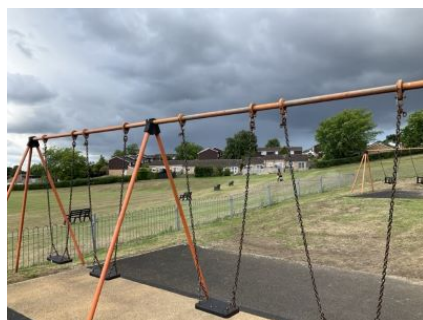
There is wear in the bushes.

There is wear to bushes.

Remove shackle bolt and check bush and shackle pin wear, replacing as necessary.

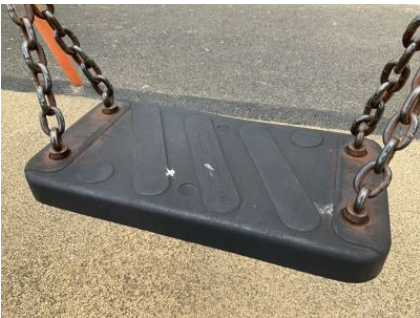
Loose swing seat eye-bolts.

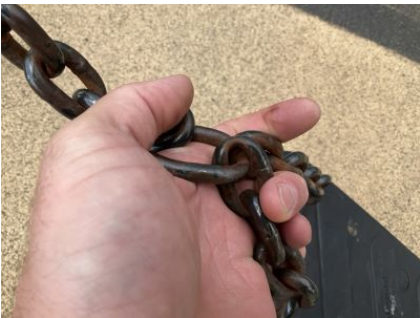
Some chain wear.

Monitor for further deterioration and replace before 40% wear.

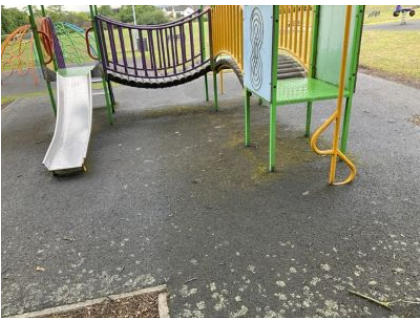
Algae growth giving slippery conditions.

Surface and unit.

Powerwashing is recommended. Care should be taken to ensure that the material can sustain high pressure washing.

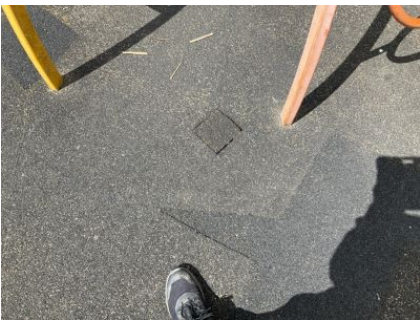
Surface is cracking in some areas.

Repair.

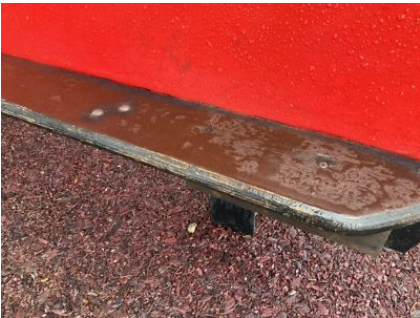
Laminate damaged.

Rub down and treat damaged edges.

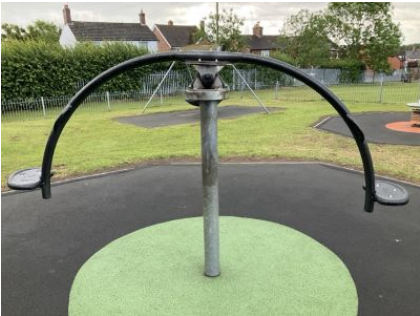
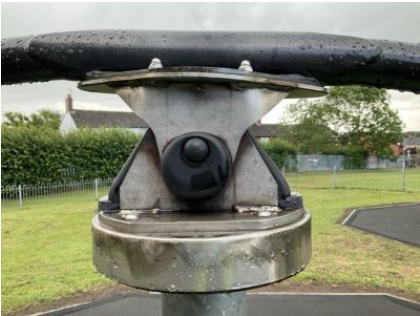
Fixtures loose or missing.

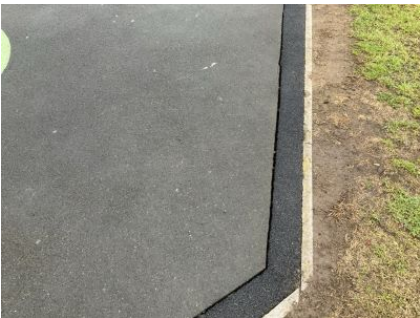
Shrinkage / separation of the surface. This may give a trip hazard.

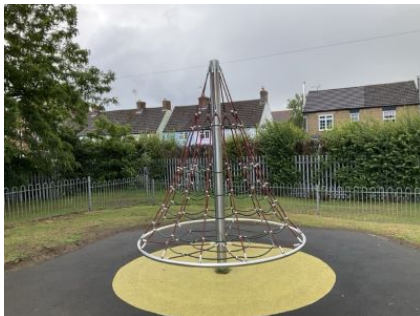
Dismantle for internal inspection of bearings as there is more movement than normal. Bearings could be worn.

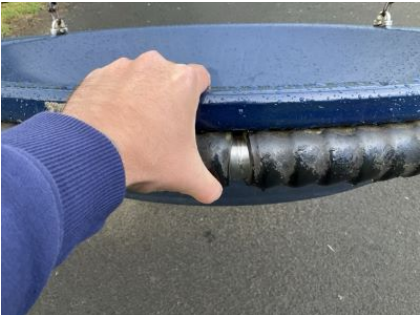
Additional comments are noted below.

Rubber edge of swing seat is displaced exposing the metal centres. Reposition rubbers.

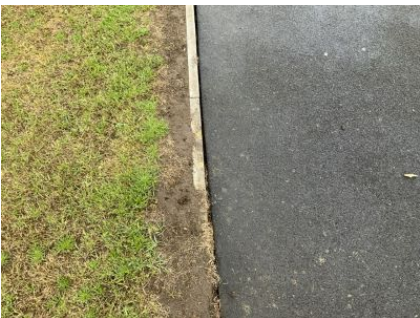
Shrinkage / separation of the surface. This may give a trip hazard.
